Lodi

Area Fire/EMS Station

Study

City of Lodi and Townships
of Lodi and West Point

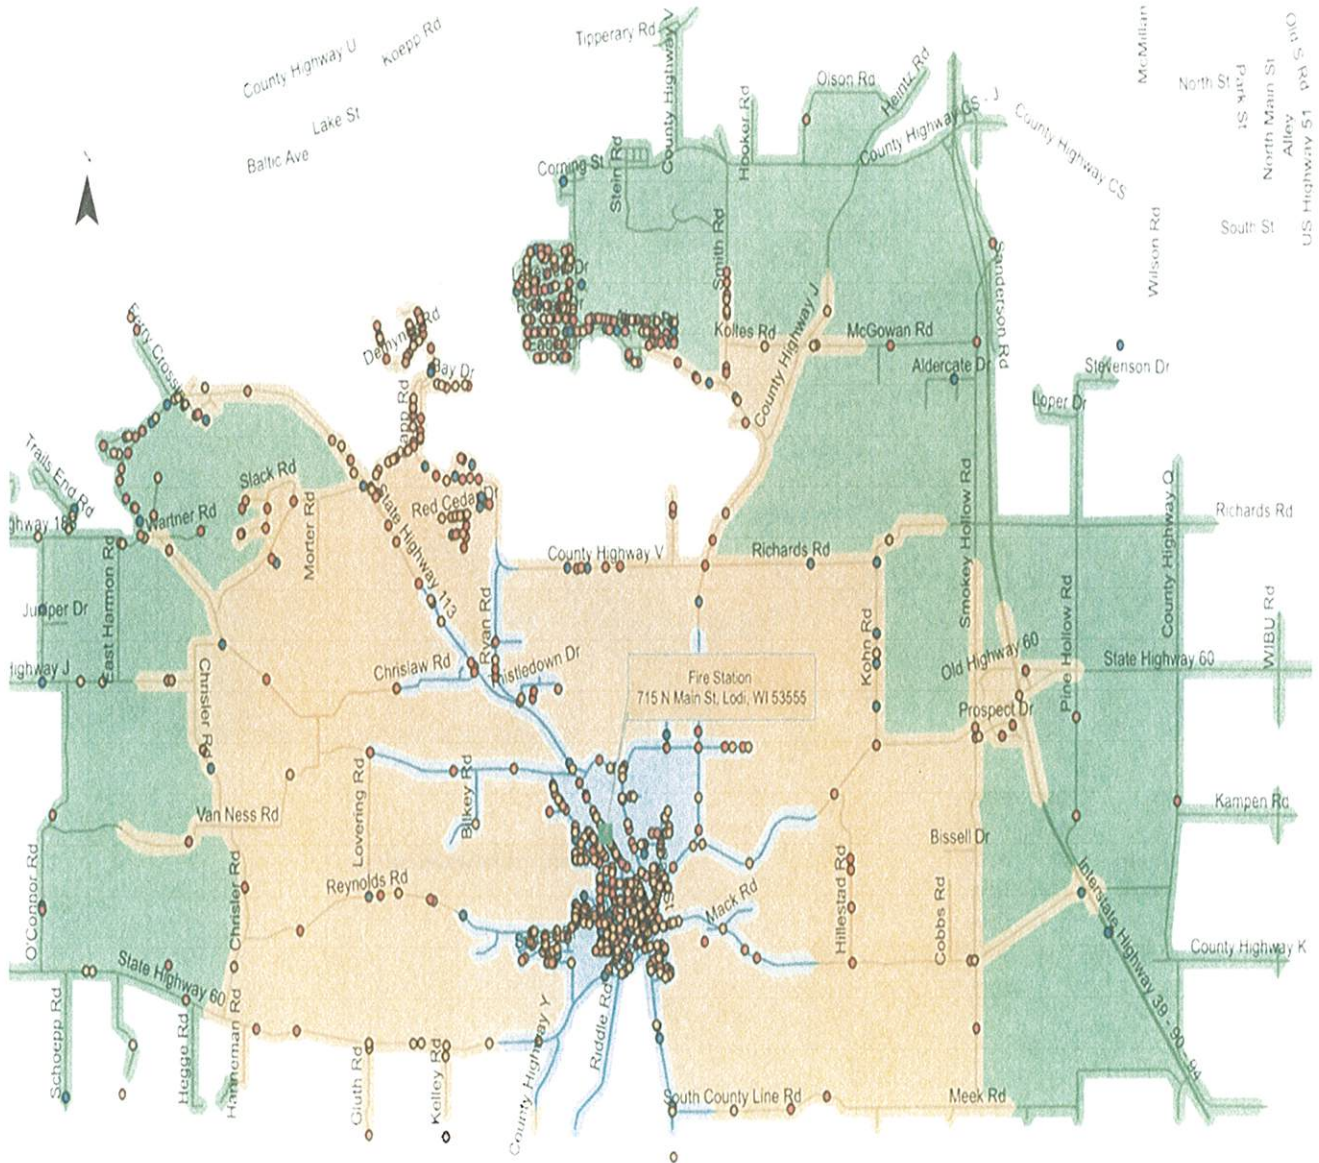
Map 2

Current EMS Station Location Time Based Response and Location of Calls for Service

Response Time	Year
Under 15 Minutes	2014
15-20 Minutes	2015
20-25 Minutes	2016
Over 25 Minutes	2017

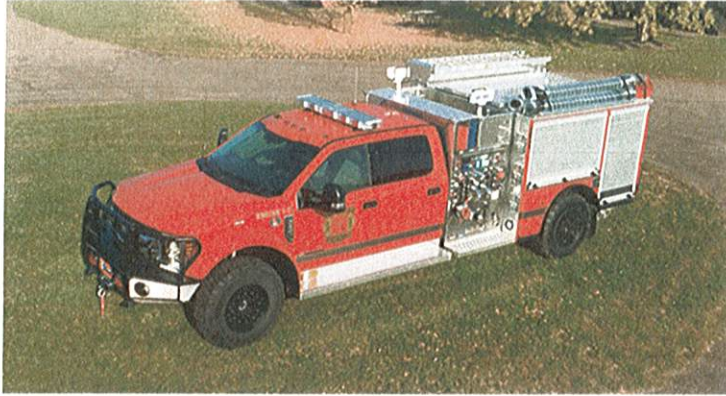
Appendix B

Example of NFPA 1901 minimally compliant fire engine to meet minimum ISO fire apparatus requirement

the scope of our project to review operations in depth, our recommendation to control cost and meet minimal ISO needs is to place a mini pumper apparatus on this station. This pumper would need to meet minimum ISO recognition as a fire engine/pumper so it would have to meet NFPA 1901 fire engine apparatus specifications. These minimum requirements are a 750 GPM pump, 300 gallon water tank, and minimum equipment carrying capacity for hose, ladders and tools. There are standard apparatus designs that fit this specification and cost is in the range of \$250,000 to \$300,000 dollars versus the cost of a full-sized engine of \$550 to \$700,000. There are also some advantages of adding this type of apparatus to the fleet in that its size improves accessing structures with long narrow driveways and steep terrain. An example of this type of apparatus is shown in Appendix B.
